Government of **Western Australia**
Department of **Health**

Guidance Note on Asbestos Cement Roofs

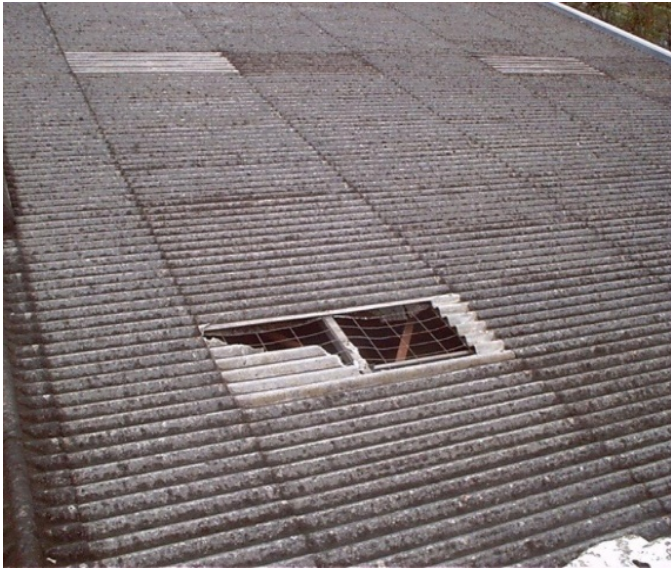
Photo 1. ACM corrugated roofing

- Brand name of “Super Six”;
- Usually 7 ridges per 1 metre wide panel; and
- Use of diamond shaped metal fasteners.

The associated ridge capping and cornices are also normally ACM, and sometimes the gutters and down pipes. More rarely the roof may be as flat or profiled sheeting or imitation slate tiles.

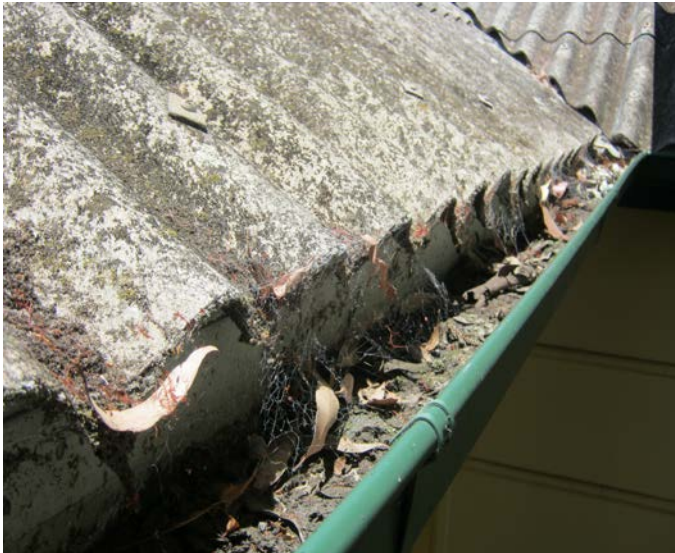
Photo 3. Asbestos fibre “whiskers” on roof lips

In the case of ACM roofs, deterioration primarily comes from weathering which erodes away the cement matrix from around the asbestos fibres. This allows more ready release of those fibres as they lose their binding or are more easily exposed to breaking off. Although very slow it occurs much faster than fences (capping excluded) or other ACM cement products that are often protected by paint or a sheltered position. An indication of condition is the degree of raised fibre above the roof surface and also the amount of fibre “whiskers” or “dags” that collect at the downward edge of the roof, as seen in Photo 3.

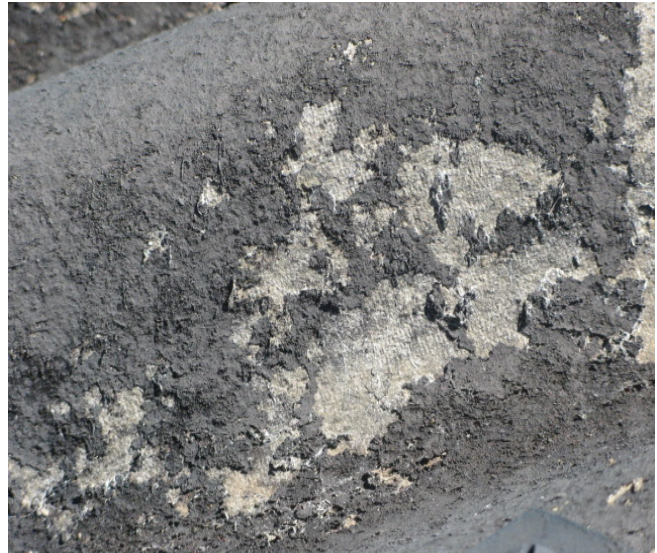
Photo 4. Surface flaking from weathering

In worse cases, flaking of the ACM surface may occur revealing lighter patches of less weathered material underneath (photo 4).

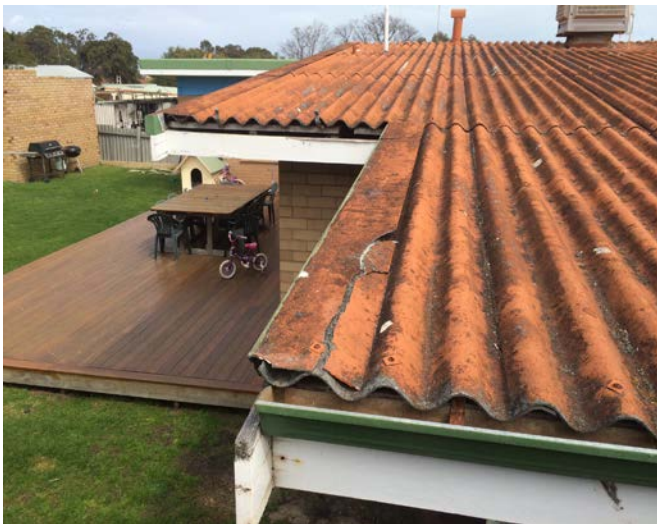
Photo 5. Part un-guttered painted ACM roof

If the roof has no or compromised guttering (photo 5), or if the downpipe outflow is on the ground surface (photo 6), the fibres and asbestos debris will deposit on the adjacent ground. This process is dangerous as it brings the fibre down into the area where people may be more likely exposed. If the rainwater feeds into a storage tank the dangers associated with any transferred fibre become more complicated, depending on the use of the water. The concern would be if the water is used in such a way that it evaporates and leaves the fibre as residue such as for watering plants.

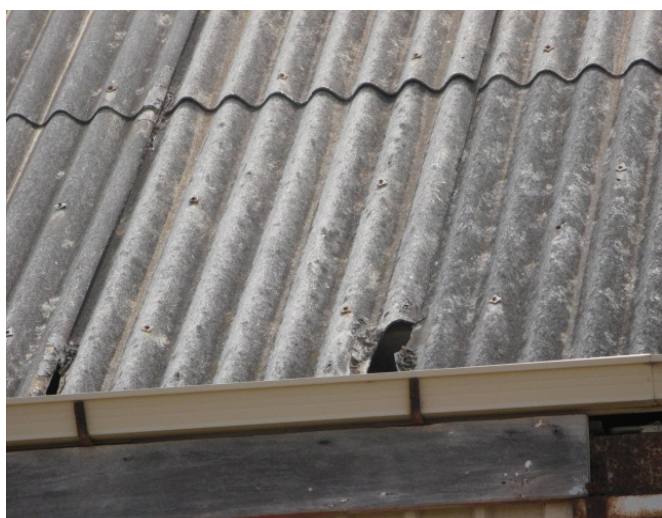
Photo 7. ACM roof breakages

Also as the ACM roof ages and the sheet thickness reduces it becomes both weaker and more brittle, and so more prone to collapse if subject to physical damage. The primary concern here is the possibility of people falling through the roof if they walk on it. But weakness also means that it will more easily break from other causes (photo 7), such as hail or falling branches and so release fibres. These weakened roofs are also more likely to shatter explosively and contaminate adjacent areas if they are subject to fire or internal explosions, such as in photo 8.

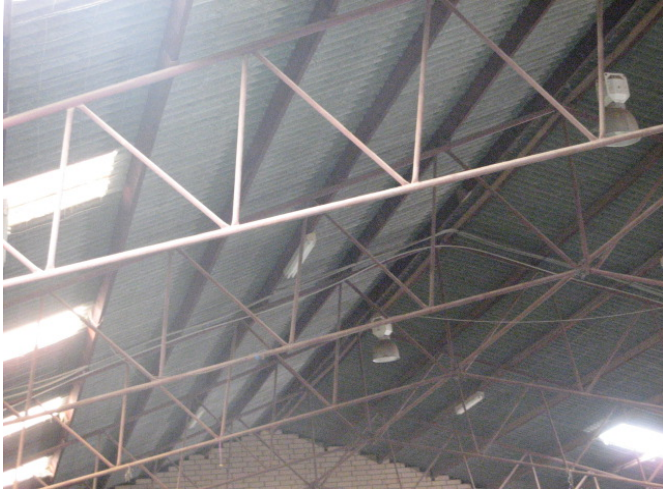
ACM roofs have been associated with ACM dust contamination of unlined sub-roof areas, likely due to the abrading of overlapping ACM sheet edges with temperature changes. This has been detected in larger commercial and public buildings such as sports halls where the lack of a ceiling resulted in ACM dust contamination of underlying occupied areas (photo 9). In the case of residences such contamination is more likely to be confined to the ceiling space and based on size may be less, but will increase in level and associated hazard the longer the roof stays in place.

Photo 9. ACM dust settlement from sports hall roof Photo 10. Tree causing damage to ACM roof

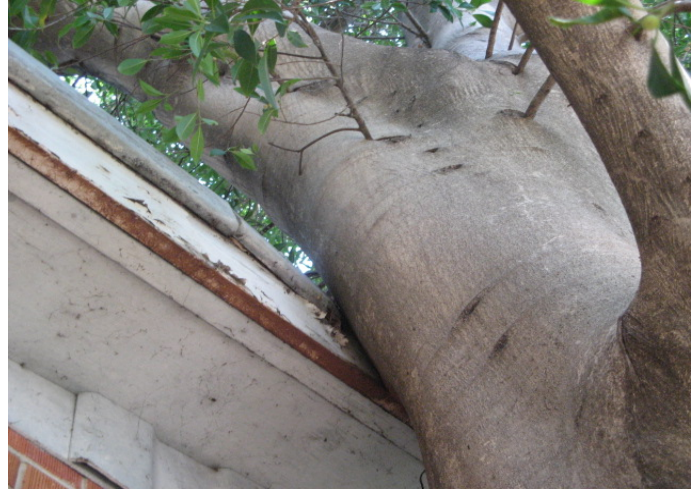
If trees branches are in contact with the roof it is possible that their movement with the wind will abrade the panels and capping and result in the release asbestos fibres. Large trees tend to be quite common in association with era of ACM houses because of the block size then and the opportunity to have grown large enough in the meantime (photo 10).
